Cardrona Tower, Cardrona, near Peebles, Scottish Borders

Historic Building Recording

AOC 21714

Historic Building Report

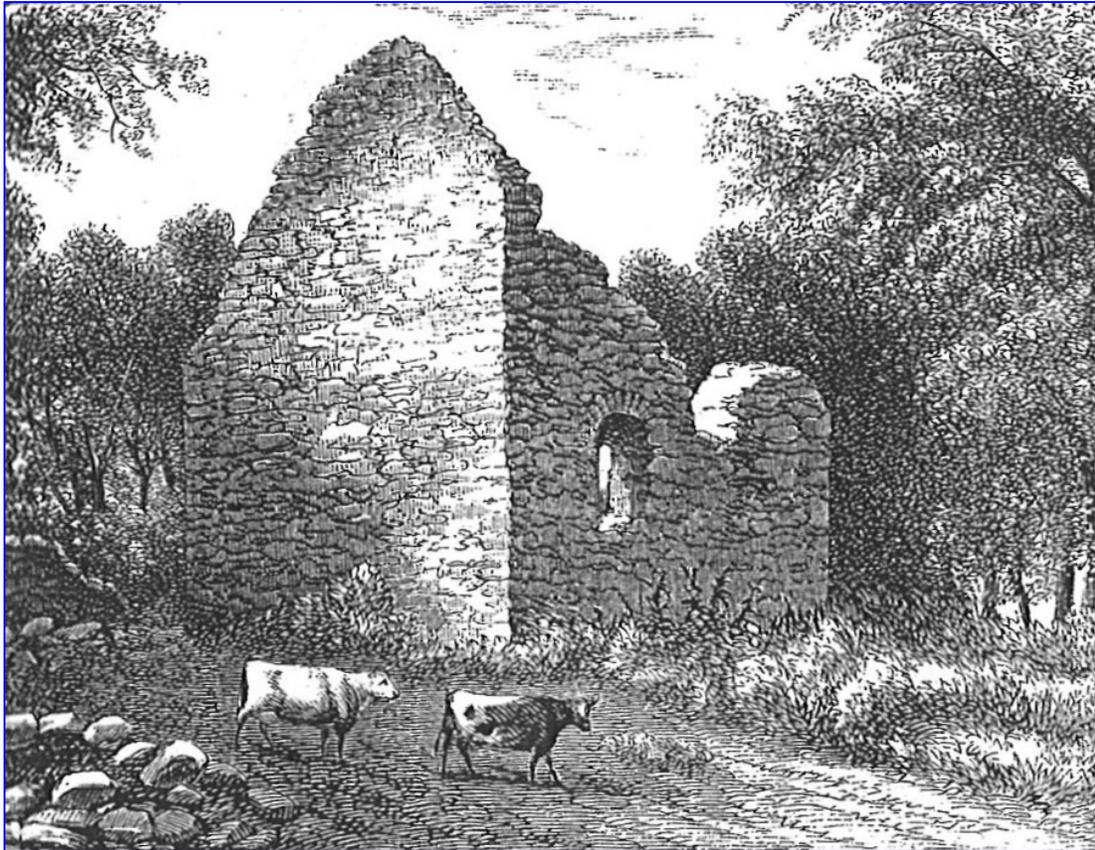
Etching of Cardrona Tower from the east, after Chambers 1864, 71

4.3.3 In the 1860s, in his study of Peeblesshire, William Chambers inserted an engraving of Cardrona Tower, which is assumed to be contemporary with the publishing of his volume in 1864 (see below). The ruin looks much as it does now, with the tall gable to the south-east elevation and the exposed remains of the windows on the north-east. The boundary wall to the south, however, survives more intact than it does today, it being now completely overgrown.
