Cardrona Tower, Cardrona, near Peebles, Scottish Borders

Historic Building Recording

Report

AOC 21714

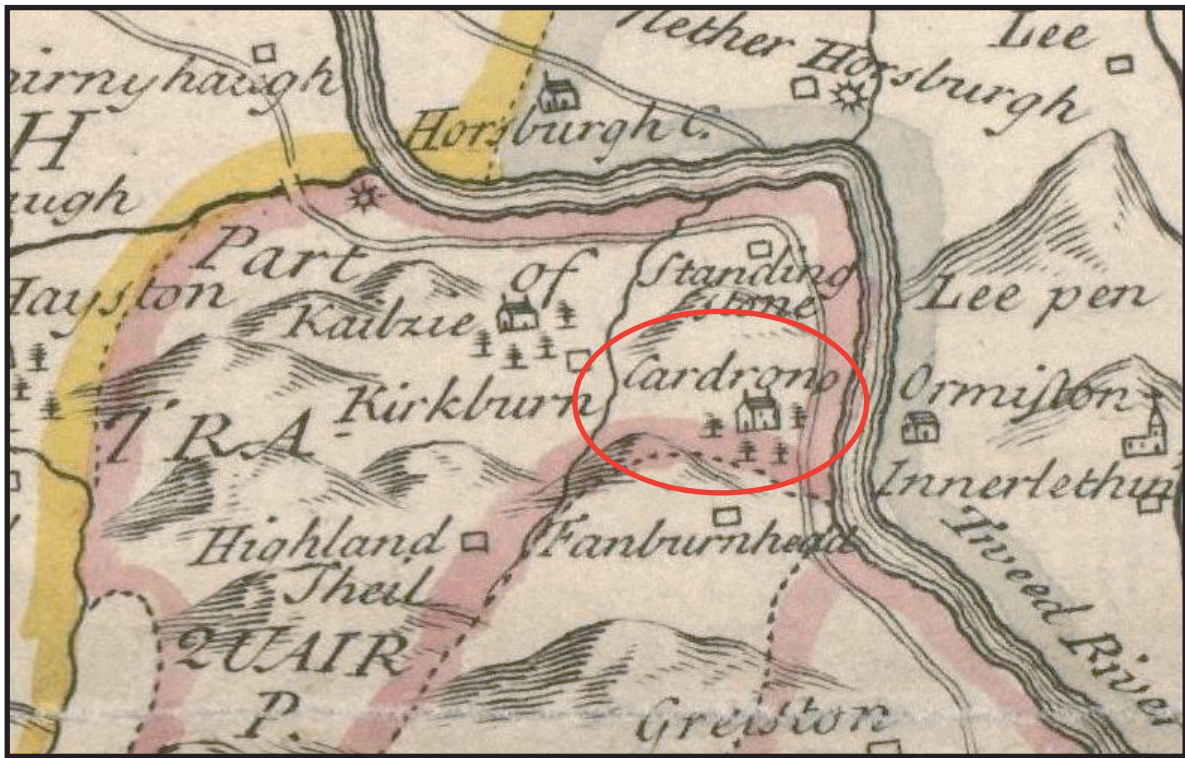
Figure 2: Extract from William Edgar's map, 1741

4.3.1 The first depiction of a settlement at Cardrona in the historical map record is in William Edgar's 1741 map (Figure 2), followed shortly after by the more detailed map by General Roy in ca. 1747-55 (Figure 3). Both these maps appear to omit the tower (as it would have been a ruin) although the main 'new' house and surrounding land and gardens are identified. The 1794 Statistical Account of Scotland very briefly mentions Cardrona Tower as one of several tower houses in the parish at the time. It describes the tower houses as '*...a continued chain...so situated on both sides of the Tweed, as by the lights placed in them, intimation might be given from one to another of the approach of any foe.*' (Walker, 1794, 378).

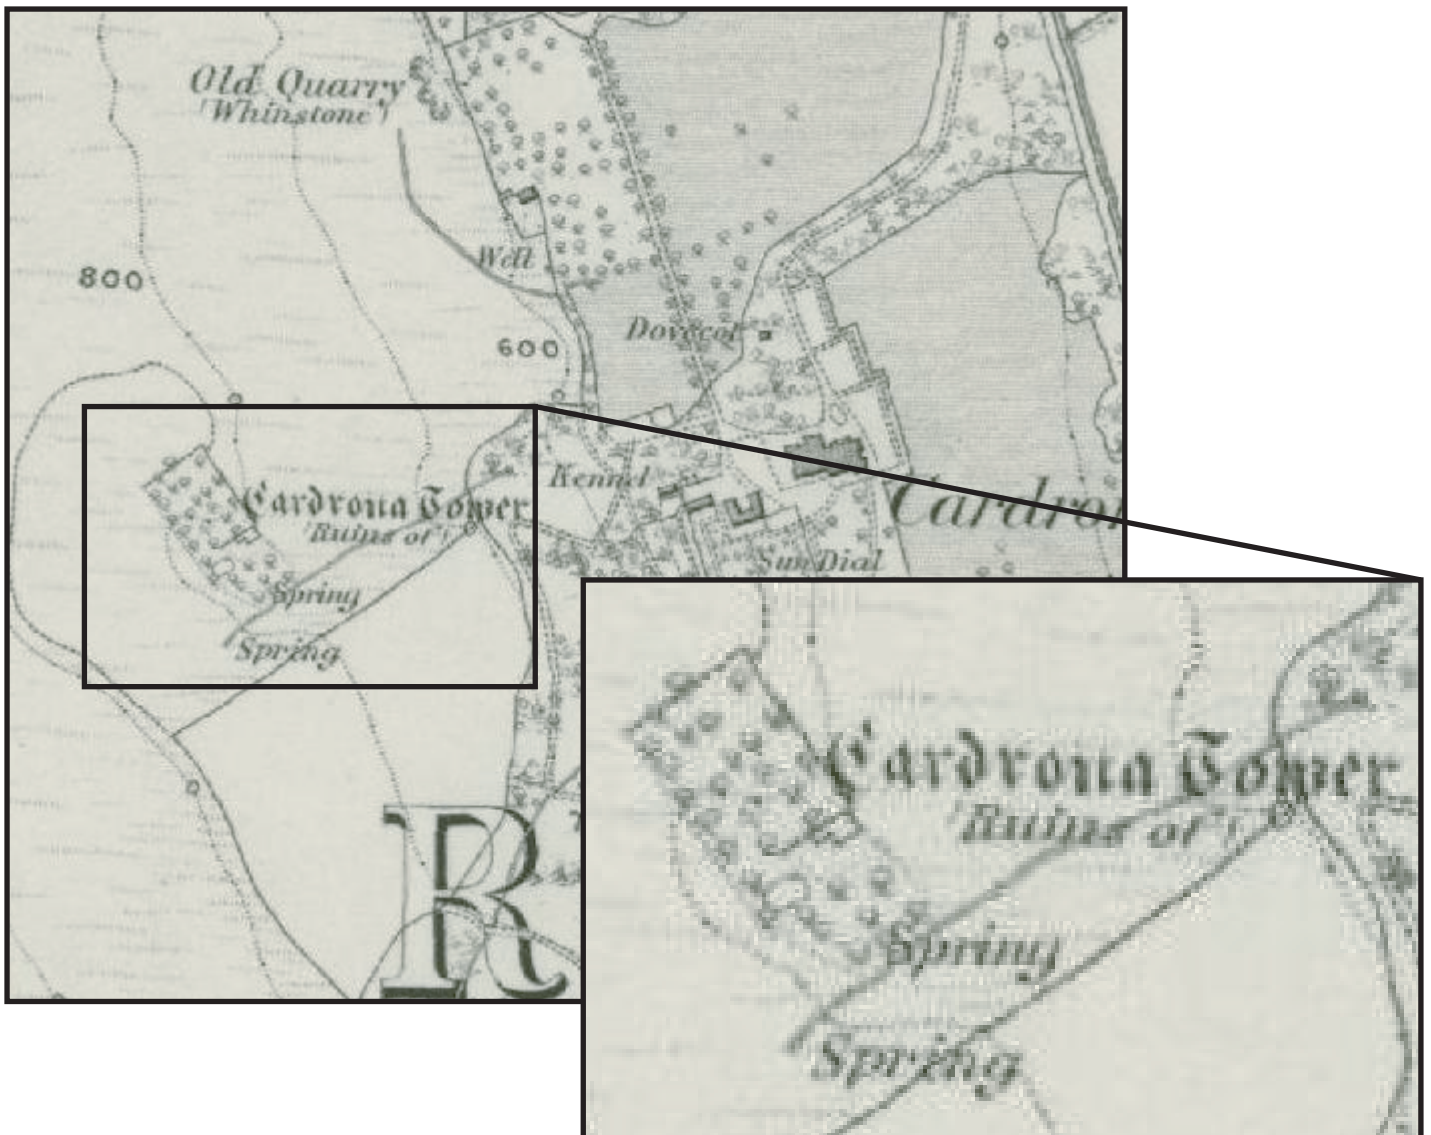
Figure 5: Extract from Ordnance Survey map, 1855

4.3.2 On Thomson and Johnson's map of 1820 the tower is depicted to the west of the house (Figure 4). Then in 1834, the New Statistical Account of Scotland records that the estate of Cardrona is owned by a 'Miss Williamson', also mentioning that it has long been in possession of these families (Campbell 1834, 42). The 1855 Ordnance Survey map marks the ruin within the forest, which has been identified as an L-shaped building (albeit on the wrong alignment) with a rectangular enclosure of land to the north-west and south-east (Figure 5).

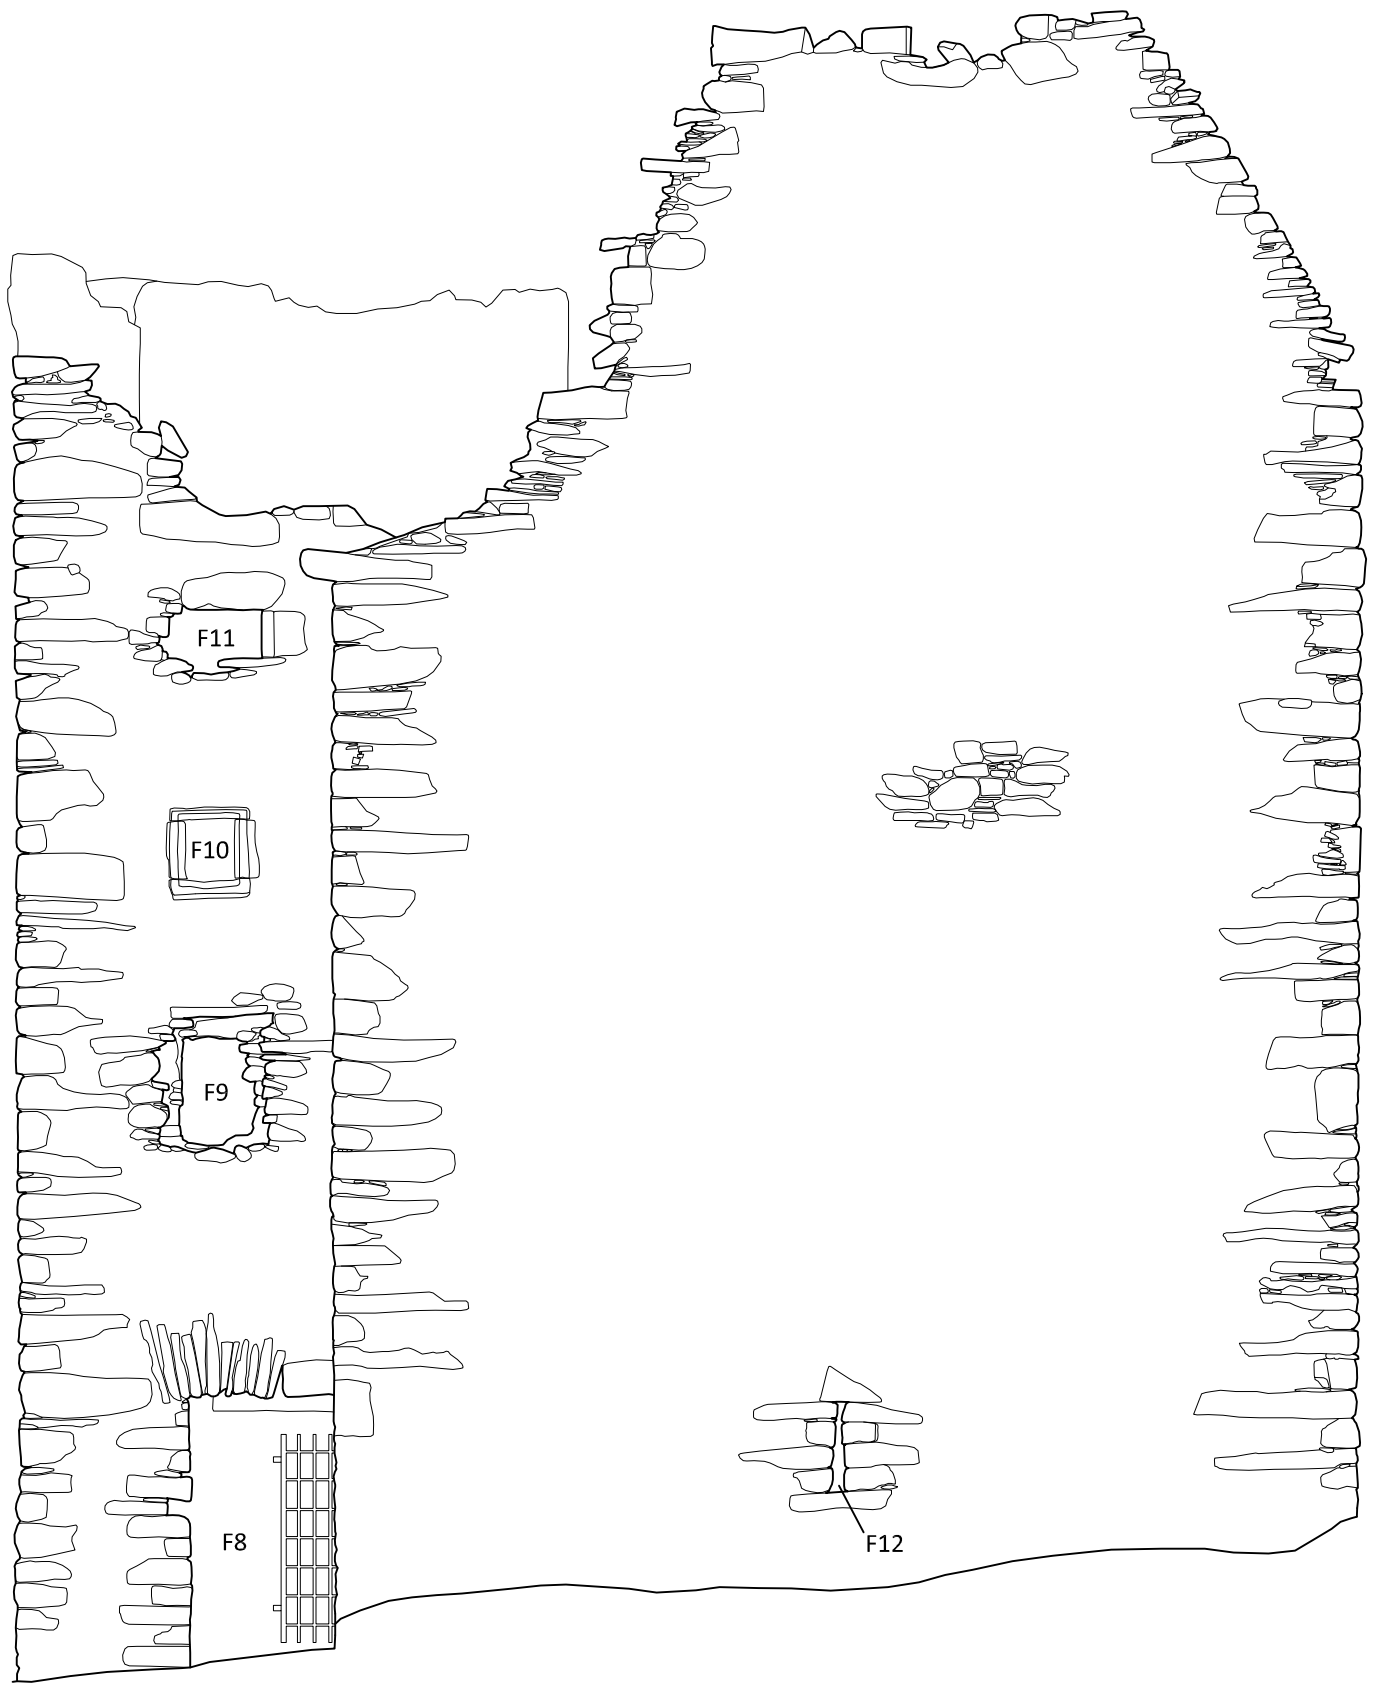
Figure 15: External south-east elevation

5.4.1 There are two elements to the south-east elevation. To the west side is the projecting main entrance to the stair tower (Figure 15; Plates 13 & 14). To the east is the elevation of the main tower (Plate 14). The stair tower entrance is a single bay with a number of openings at each floor level. The main entrance (F8) to the stair tower, Room 0/2, is off-set from its relieving arch on the north side, and this is recorded as being a later repair of the mid-20th century (RCAHMS 1967, 221). The mortar around the edge of the doorway and in the relieving arch certainly looks different to that seen elsewhere in the building. The entranceway curves in to the south side giving entry to the circular stair within (Plate 15). Above this is a crude window F9 with no discernible surround, probably robbed out (Plate 16). Above this feature is a moulded surround for a plaque (F10) for an armorial shield (now removed) (Plate 17). At the very top of the surviving wallhead is another window F11, a flat rectangular window with a large moulded surround surviving the north-east side; although those to the opposite side, this has been removed on the other side (Plate 18). This forms the only real remains of any dressed stonework on the openings that survives (apart from F10) and it has remained so probably due to its inaccessibility!

| Feature No | Elevation | Room | Description | Measurements (width x height in mm) |
|---|---|---|--|--|
| F8 | SE | Room 0/2 | Main doorway leading to the stair tower, looks to have been altered and/or repaired on the south-west side. Relieving arch over. | 947 x 1862 |
